# Back to the Danube: Engineering a Hard Rock Breakthrough

30th DCA Annual Congress Rome

## Black Sea Shore - Podișor Gas Pipeline

#### Post Geotechnical & Geophysical Investigation on Danube River

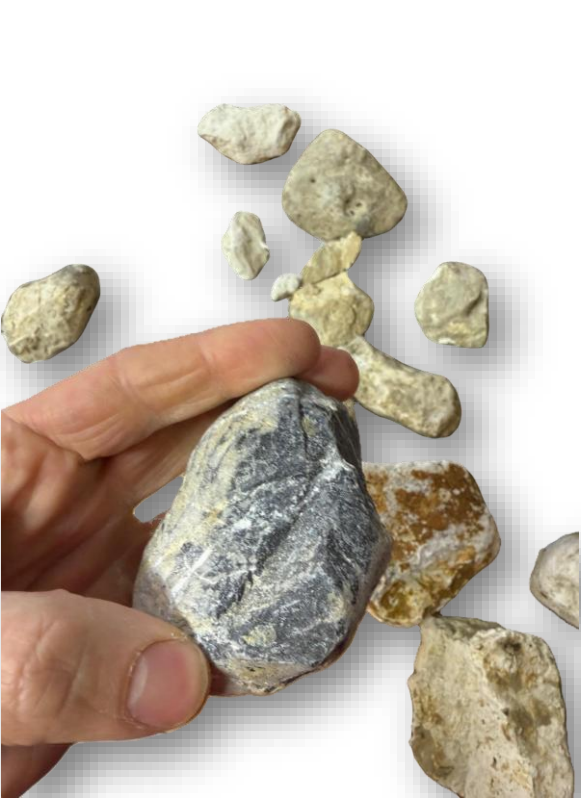
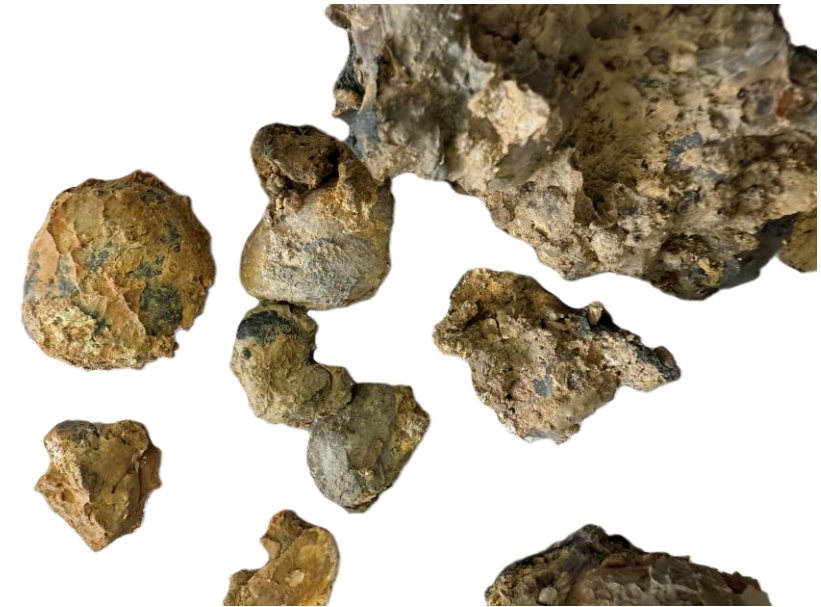
- Rapid hard-to-soft transitions
- Variable cementation and weathering
- Clay seams and fracture infill
- Changing torque, ROP, vibration and fluid behaviour

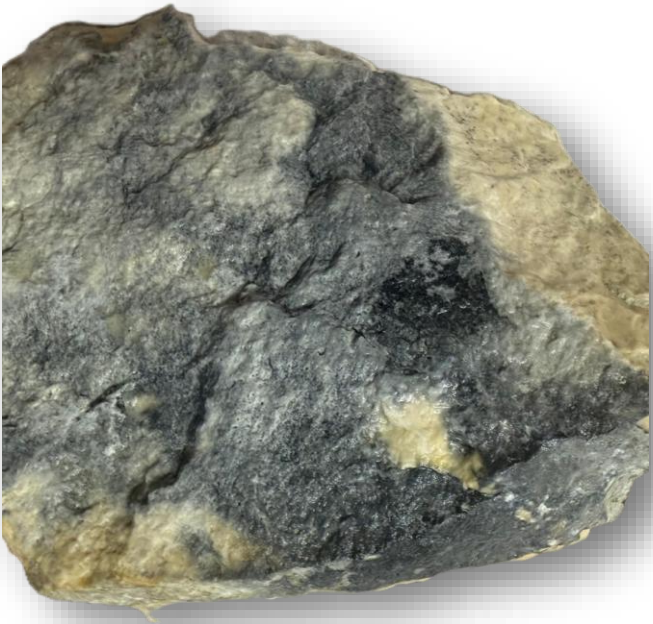
- Harder and more abrasive intervals than anticipated
- Reduced penetration rate
- Accelerated cutter wear
- More frequent inspection and tool replacement

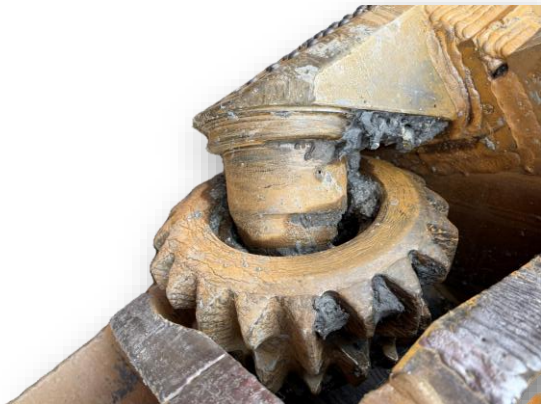
50-inch hole opener

- Large limestone boulders recovered during fishing
- Some exceeded effective cutter damage
- Increased torque and reduced drilling efficiency
- Repeated conditioning and reaming required

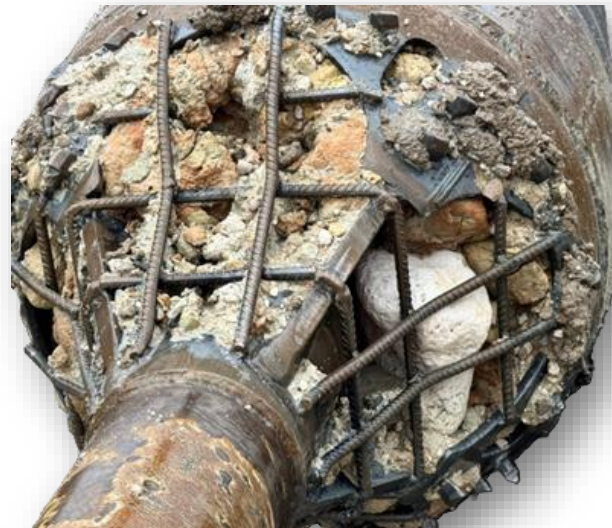
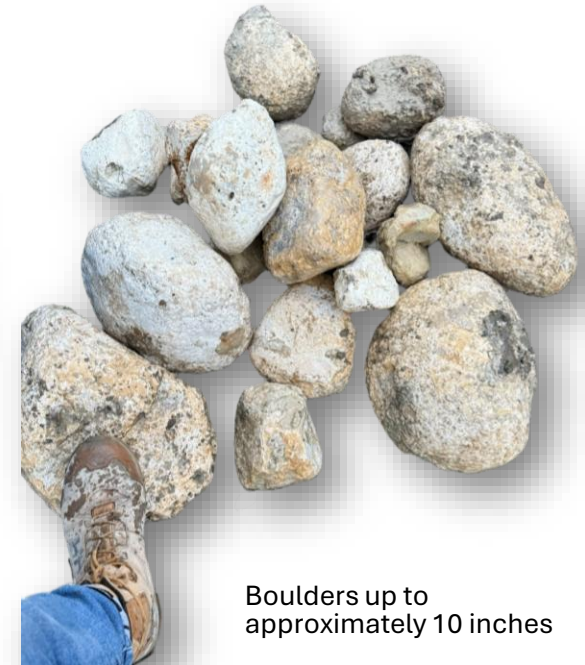
40-inch stone catcher

Boulders up to approximately 10 inches

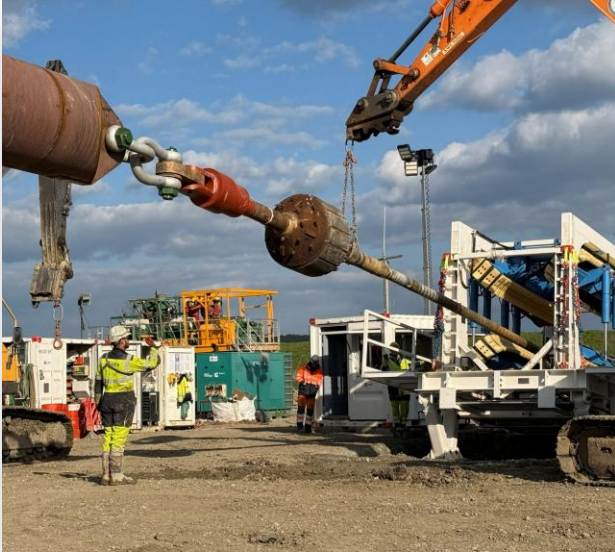
Attempt **1**

- Extensive bore conditioning
- Pipe Pusher deployed
- Installation unsuccessful

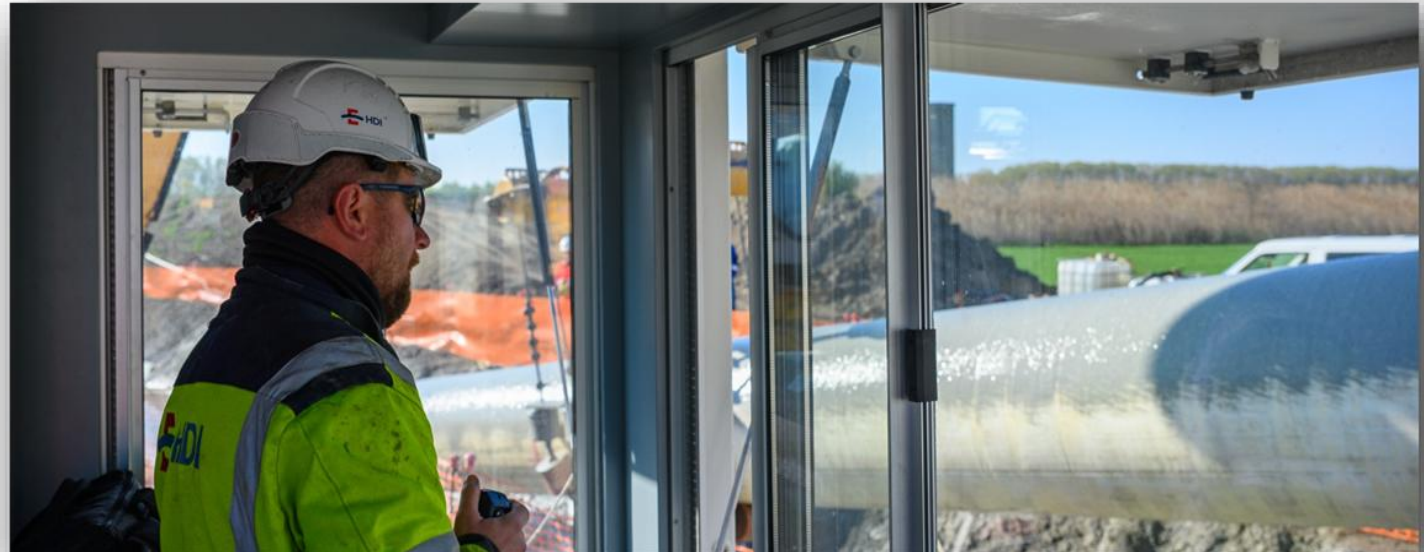
Attempt **2**

- Additional intervention
- Installation unsuccessful again

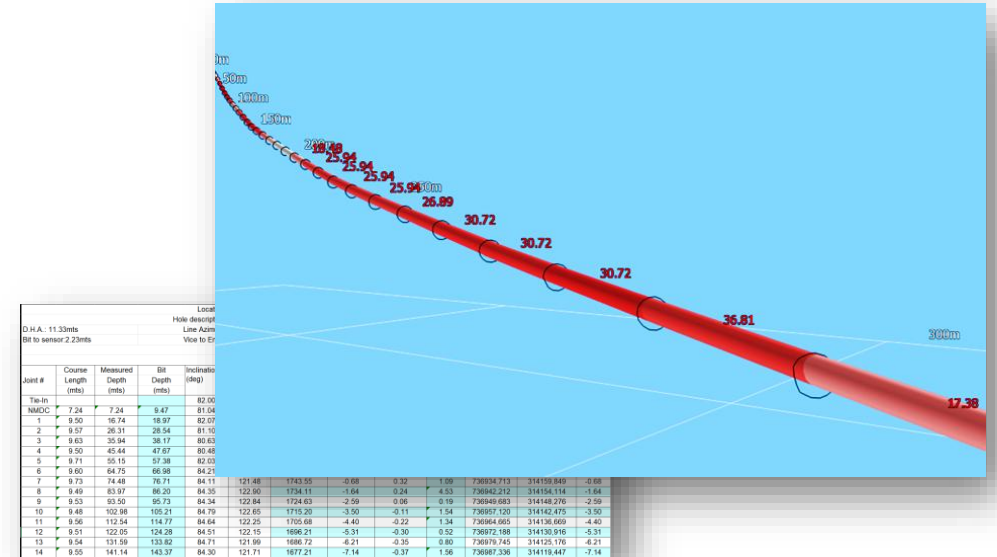
- Final steering-tool re-survey
- Actual three-dimensional bore geometry
- 40-inch pipe-to-bore contact analysis
- Local installation constraints visualized
